# Manhole Inspection Summary

Manhole # S49M\_\_014MH

Insp Date: **5/7/09 8:20 AM**

**Location** Address: **837 S MONTFORD-PORT-ALLEY** Cross Street: **ALLEY-FAIT-HUDSON**

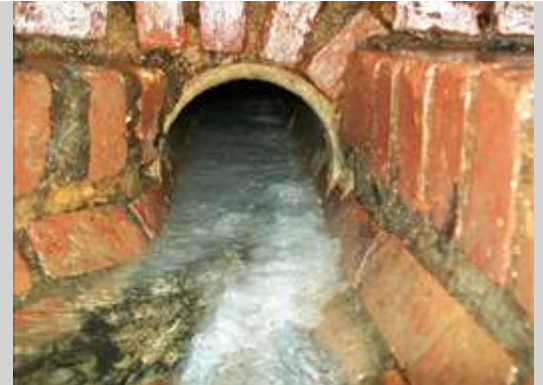
12 O'Clock Outflow

8 in. Circular Gravity Sewer  
Pipe Out @ 12 O'Clock

Pipe Height: **8.4** (in.) Rod and Bar (Angled)  
Pipe Material: **Clay** ☐ Pipe Lined  
Invert Depth: **9.75** (ft.) Flow Characteristics: **Fast**  
Deposits: ☒ None ☐ Mud ☐ Sludge ☐ Debris ☐ Grease  
Silt Depth: **0** (in.) Deposits Extent:  
Infiltration: **None** Pipe Seal Cond: **Sound**

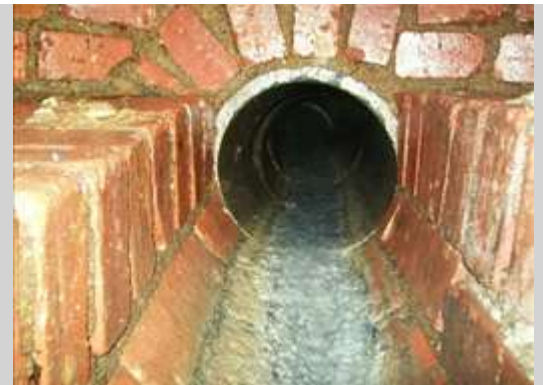
6 O'Clock Inflow

8 in. Circular Gravity Sewer  
Pipe In @ 6 O'Clock

Pipe Height: **8.4** (in.) Rod and Bar (Angled)  
Pipe Material: **Clay** ☐ Pipe Lined  
Invert Depth: **9.70** (ft.) Flow Characteristics: **Slow**  
Deposits: ☒ None ☐ Mud ☐ Sludge ☐ Debris ☐ Grease  
Silt Depth: **0** (in.) Deposits Extent:  
Infiltration: **None** Pipe Seal Cond: **Sound**
